Colombian sugar mill uses Total Organic Carbon (TOC) to prevent costly product leaks

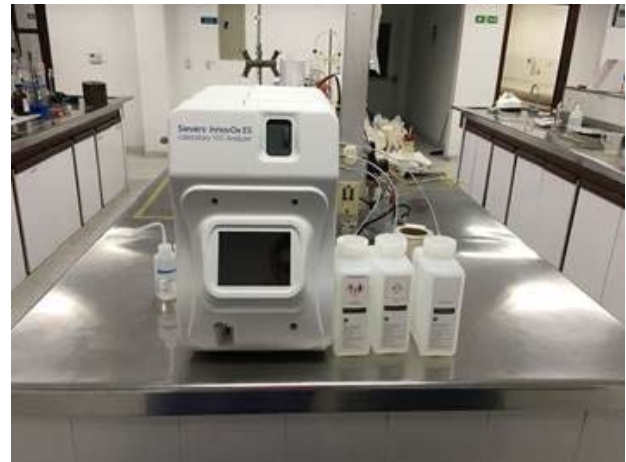
Figure 1. Sievers* InnovOx Laboratory TOC Analyzer used for Leak Detection

Sugar is a carbohydrate composed of carbon, oxygen, and hydrogen. It is easily detected with the sum parameter measurement of TOC, which accurately quantifies all organic compounds in a solution. TOC analyzers work by oxidizing organic molecules to carbon dioxide (CO₂) and detecting the evolved CO₂. Ingenio Pichichi invested in a Sievers* InnovOx Laboratory TOC Analyzer (**Figure 1**) to characterize and profile the system. This enabled the

The Sievers InnovOx Lab utilizes Super Critical Water Oxidation (SCWO) and Non-Dispersive Infrared (NDIR) Detection across a wide range of carbon from 50 ppb ($\mu\text{g/L}$) to 50,000 ppm (mg/L). Expected TOC values at the mill are likely to range from 200-500 ppm, however, an upset or a leak might cause spikes from 5,000 to 20,000 ppm TOC.
